COMMERCIAL WIND MITIGATION INSPECTION BUILDING TYPE II

Bella Marguerite Condominium Association, Inc.

3805 Gulf Blvd.

As of December 15, 2011

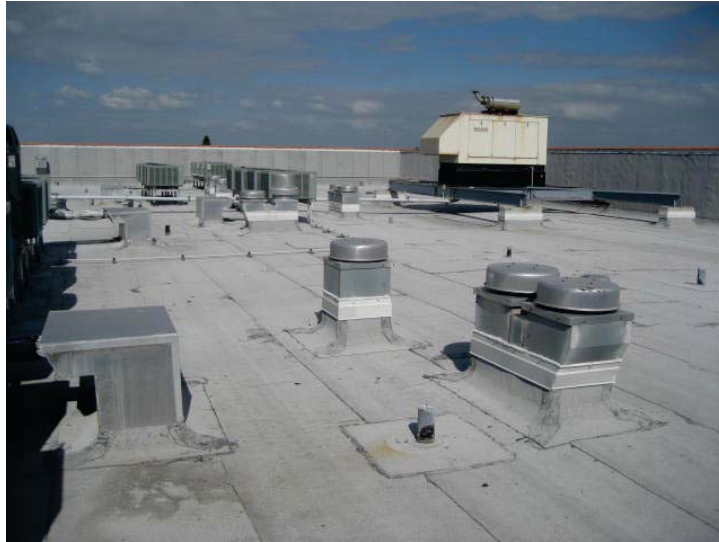
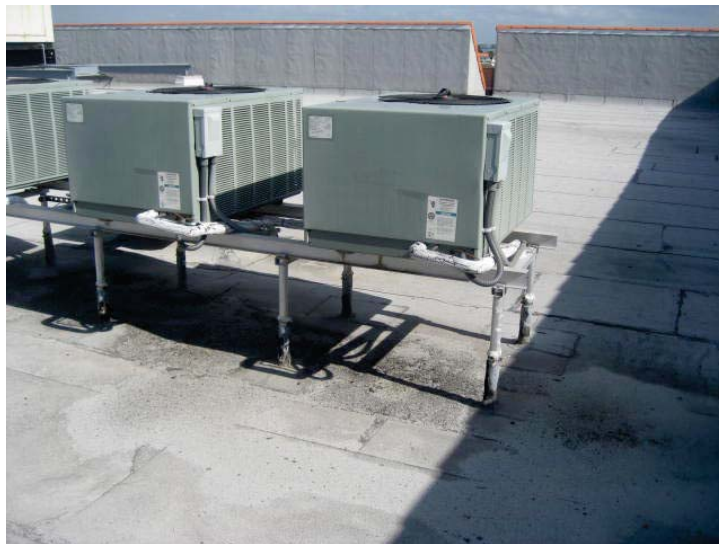
Predominant Roof Covering: B. Does not meet minimum requirements.

Inspector We are unable to approve your roof covering for compliance in accordance with the OIR-1802 Form, due to the specifications outlined on the form. The testing requirements referred to on the form relate only to testing protocols for shingle and metal roofs, not flat roof coverings.
Comments:

Roof Covering

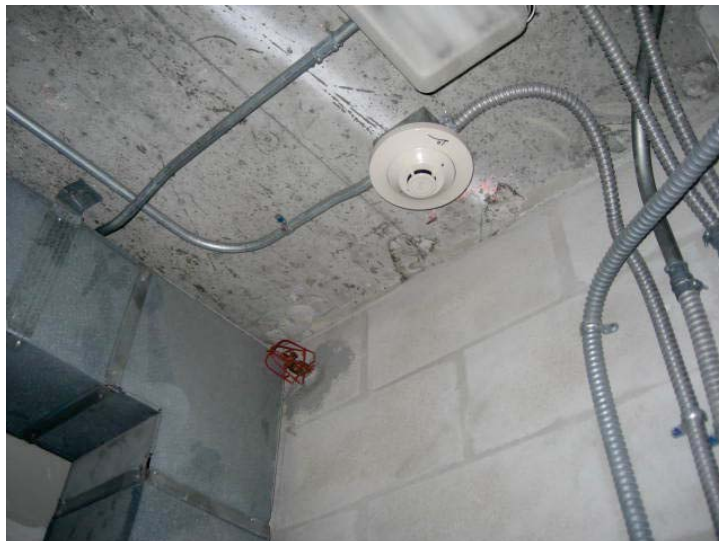
Inspector Reinforced Concrete - Inspection verified a roof structure composed of cast-in-place or pre-cast structural concrete designed to be self supporting and integrally attached to the wall / support system.
Comments:

Inspector Inspection verified a structural roof-wall connection composed of cast-in-place or pre-cast structural concrete designed to be self supporting and integrally attached to the wall / support system.
Comments:

Reinforced concrete roof deck attachment

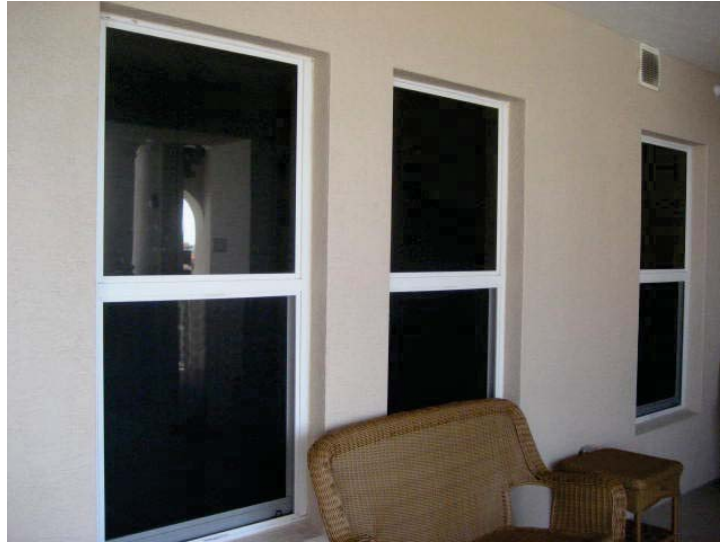
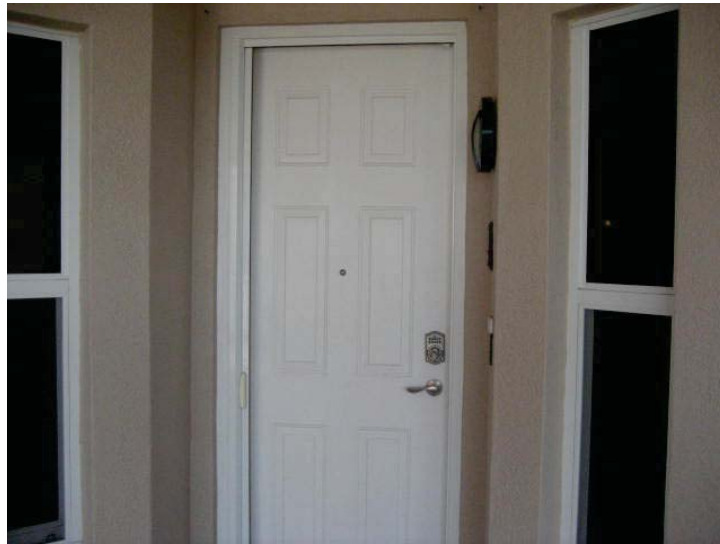
Inspector Inspection verified reinforced masonry exterior wall construction.
Comments:

Inspector Hurricane - All openings (doors and windows) were Large Missile Impact protected/rated in accordance with the respective testing procedures as outlined on the OIR 1802 Form. Based upon the year of construction current city building codes require large missile impact windows and doors.
Comments:

Reinforced masonry exterior walls | Hurricane Impact Windows and Doors

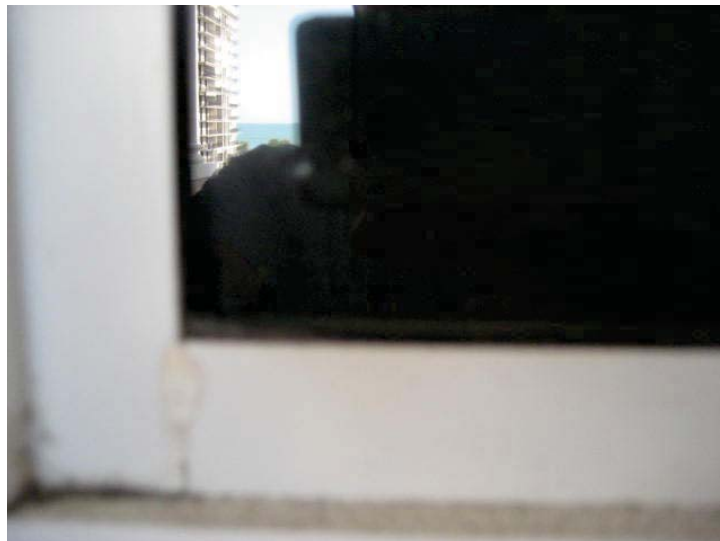
Impact window product identification
